# Automatic Vehicle Speed Management System Trials

# Automatic Vehicle Speed Management System Trials.

Issue Date: 5<sup>th</sup> May 2021 – Issue 1

Light Rail Safety Standards Board

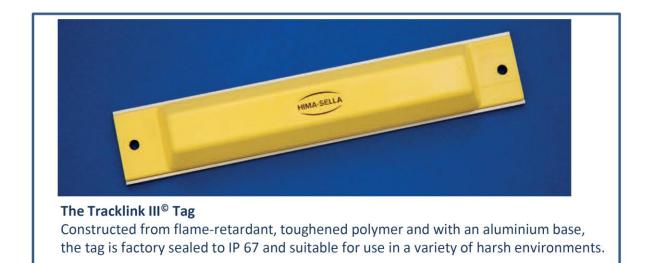
Figure 1 - RFID Tag

The PPOS system was developed from an existing location specific system used in heavy rail. This system uses Radio Frequency Identification (RFID) tags mounted between the running rails at strategic points. These tags are passive (i.e. do not require a power supply feed) and contain information about the permitted speed for the specific upcoming location and communicates this to transponder equipment mounted below the tram. These transponders feed permitted speed information to a processing unit which also receives current speed information from the vehicle. The processing unit determines if the tram speed is in excess of the maximum tolerated speed and if so, automatically applies full-service brake bringing the vehicle to a halt.

- RFID Tag breakages Whilst the RFID Tags are designed to be robust and weatherproof, there has been some damage to installed Tags by road rail vehicles. Regular inspection is required to ensure that the Tags remain in place and are in good condition.

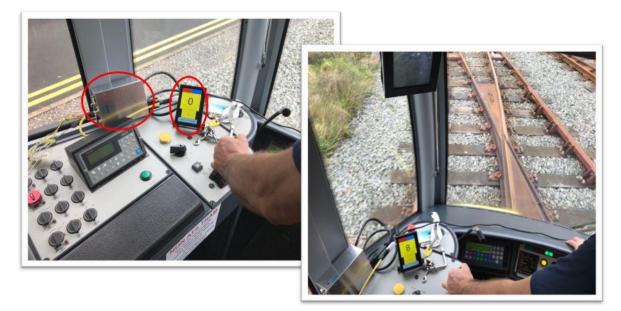
#### Figure 7 - User interface placement

A small in-cab touch screen was installed in a position where it would be visible to the driver but clear of any other equipment and not easily banged or knocked as the driver carries out normal duties. This screen should ideally be positioned no further than 1.5 metres from the SIMOVE computer. Both the ruggedised computer and screen are reasonably small and light and were easily mounted in the M5000 cabs.

The images below show the SIMOVE computer and interface touch screen in a temporary location. This provides an indication of equipment size.

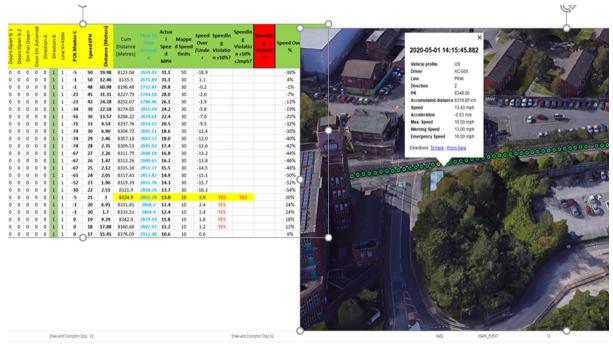
Figure 9 - System data display

SIMOVE is also able to graphically plot the trips using a "KML" file type recorded at the end of each trip. Google Earth or similar mapping software can be used to display location and vehicle acceleration characteristics along with other details. This enables efficient analysis and understanding of overspeed occurrences. It significantly reduced the time taken and improved the quality and accuracy of information compared to using OTMR data.
